V.1.2 Historical changes of the Danube riverbed from Bratislava to Komárno

V.1.2 A Duna meder történelmi változásai Pozsonytól Komáromig

Peter Pišút
Institute of Zoology SAS
Bratislava

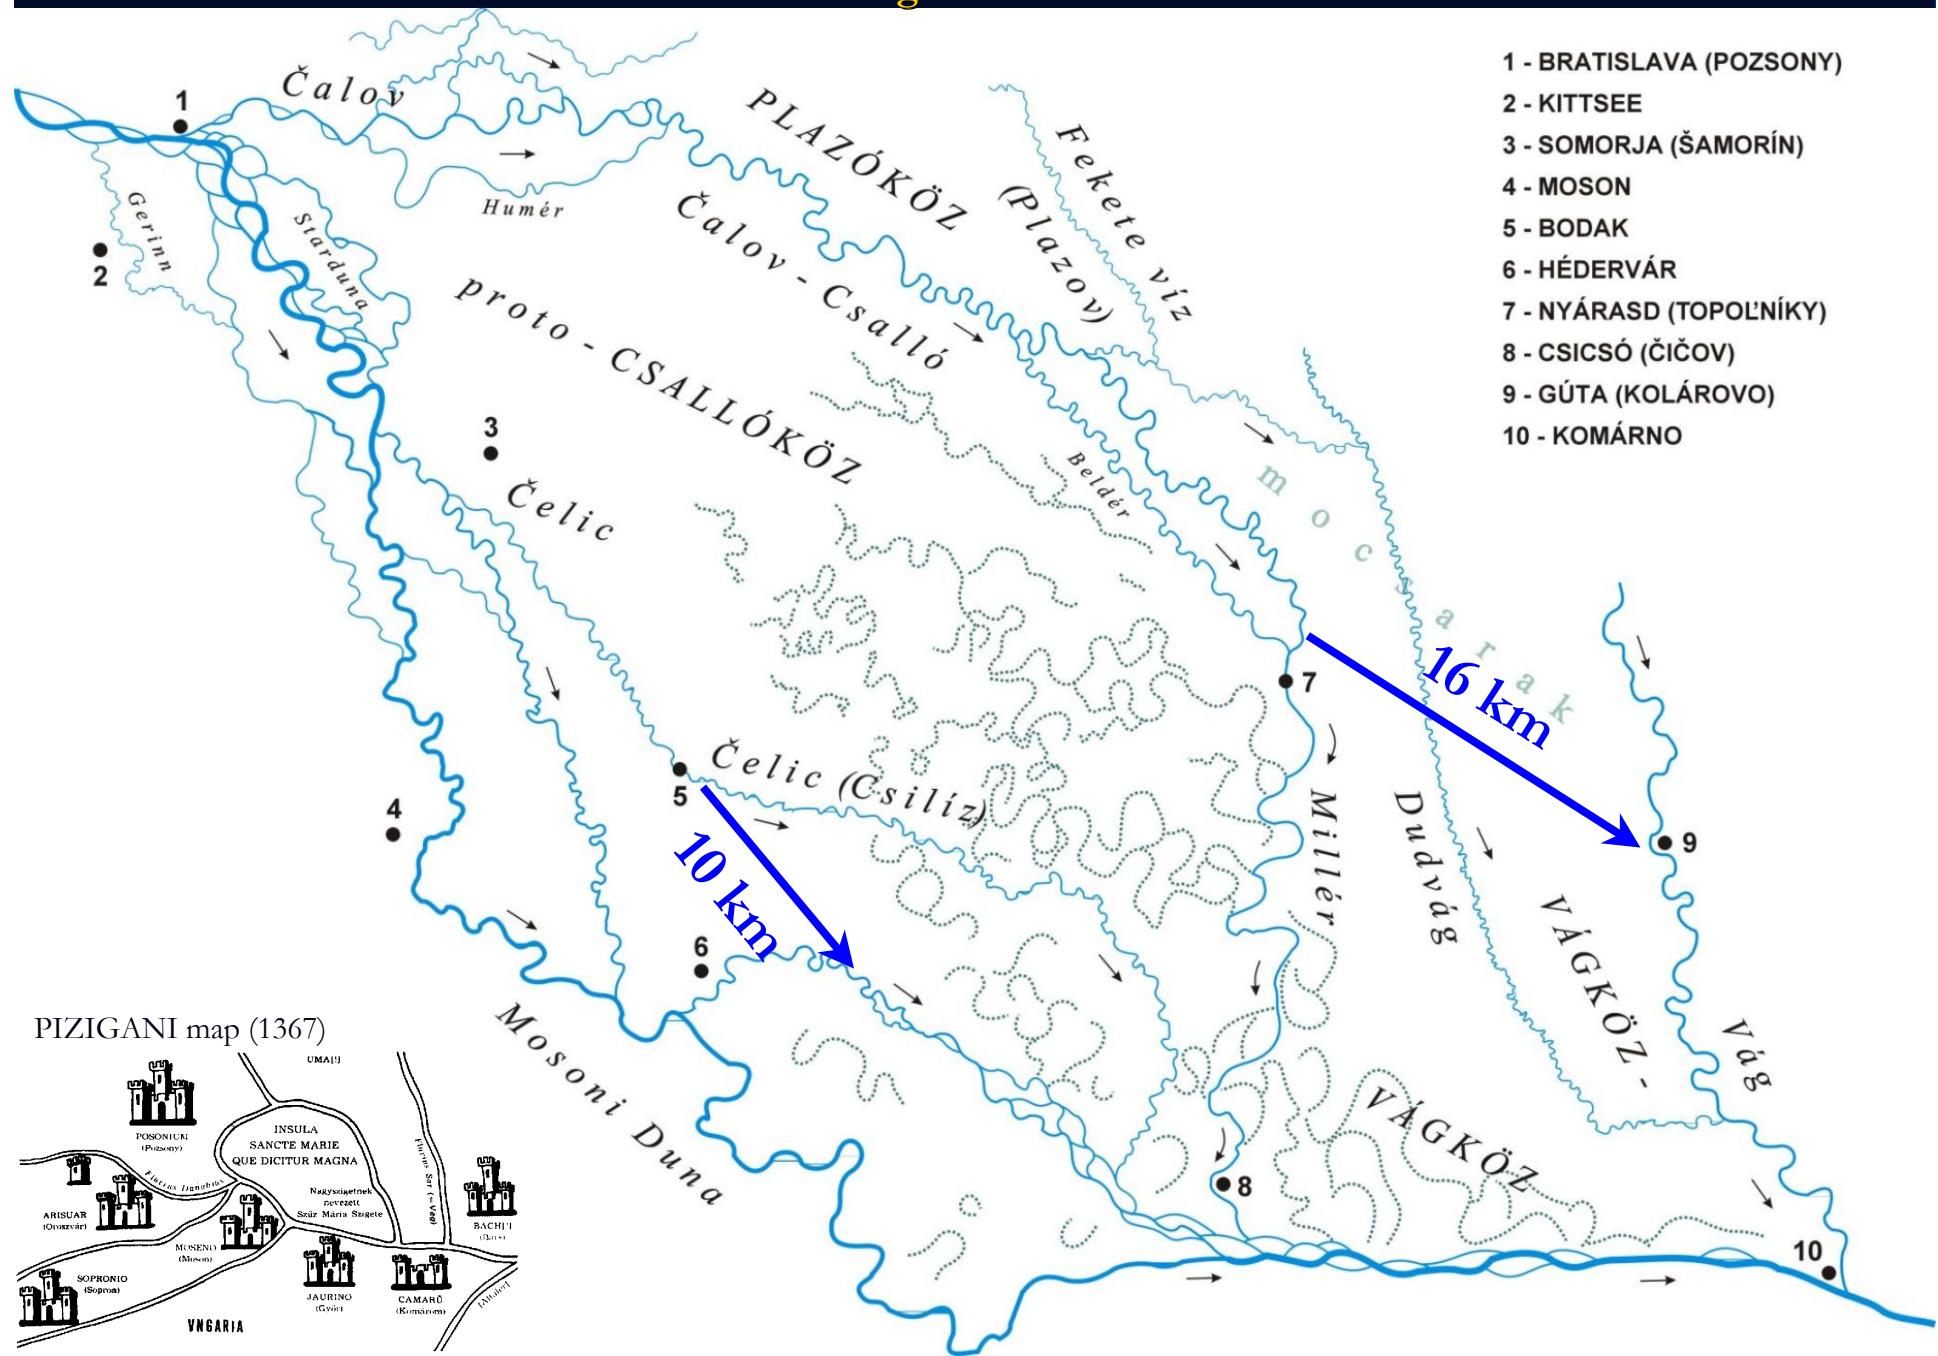
The 13th – 14th Century river network (hypothetical reconstruction)
and channel changes between 1380 and 1426

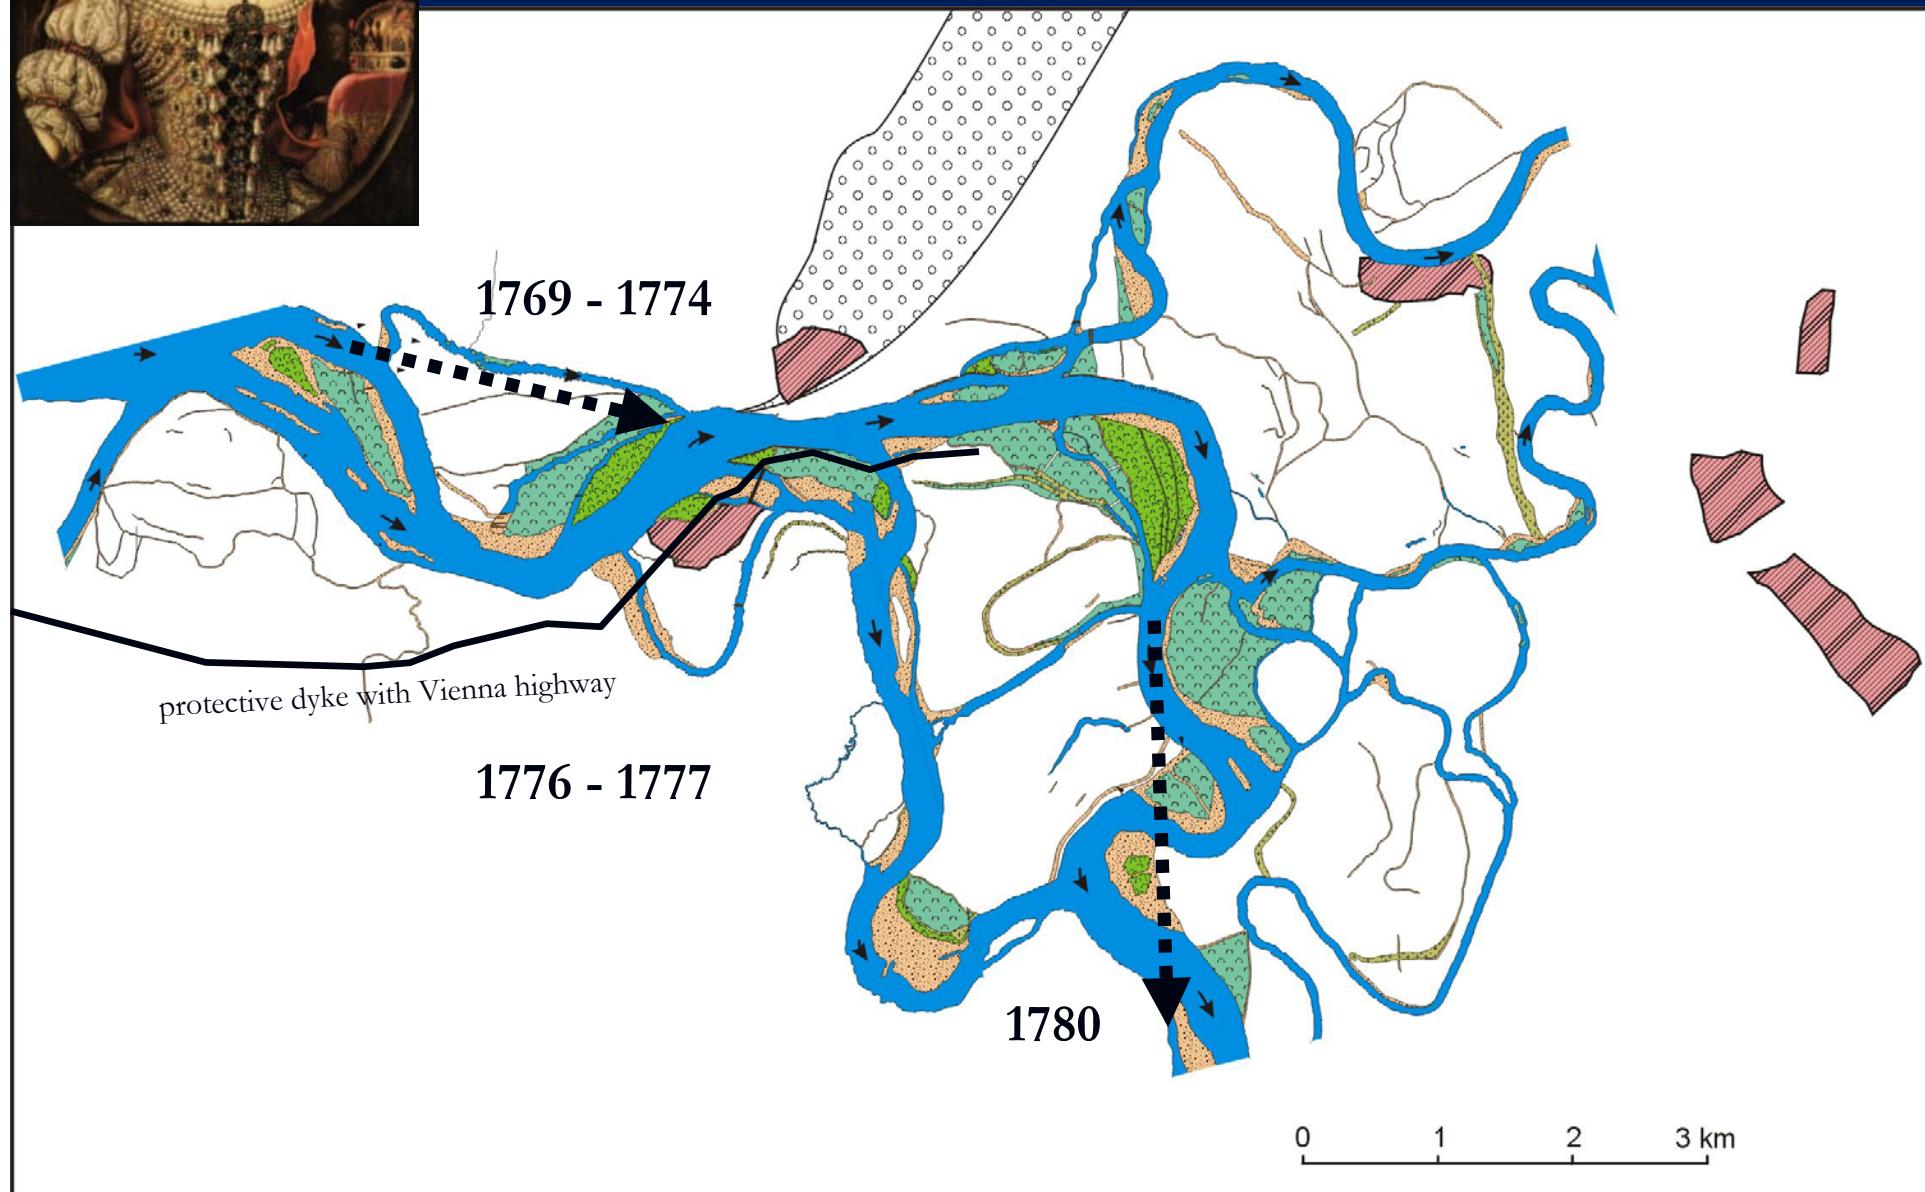
1753

Natural and human-induced channel changes
of Bratislava's floodplain (A. FRITSCH map)

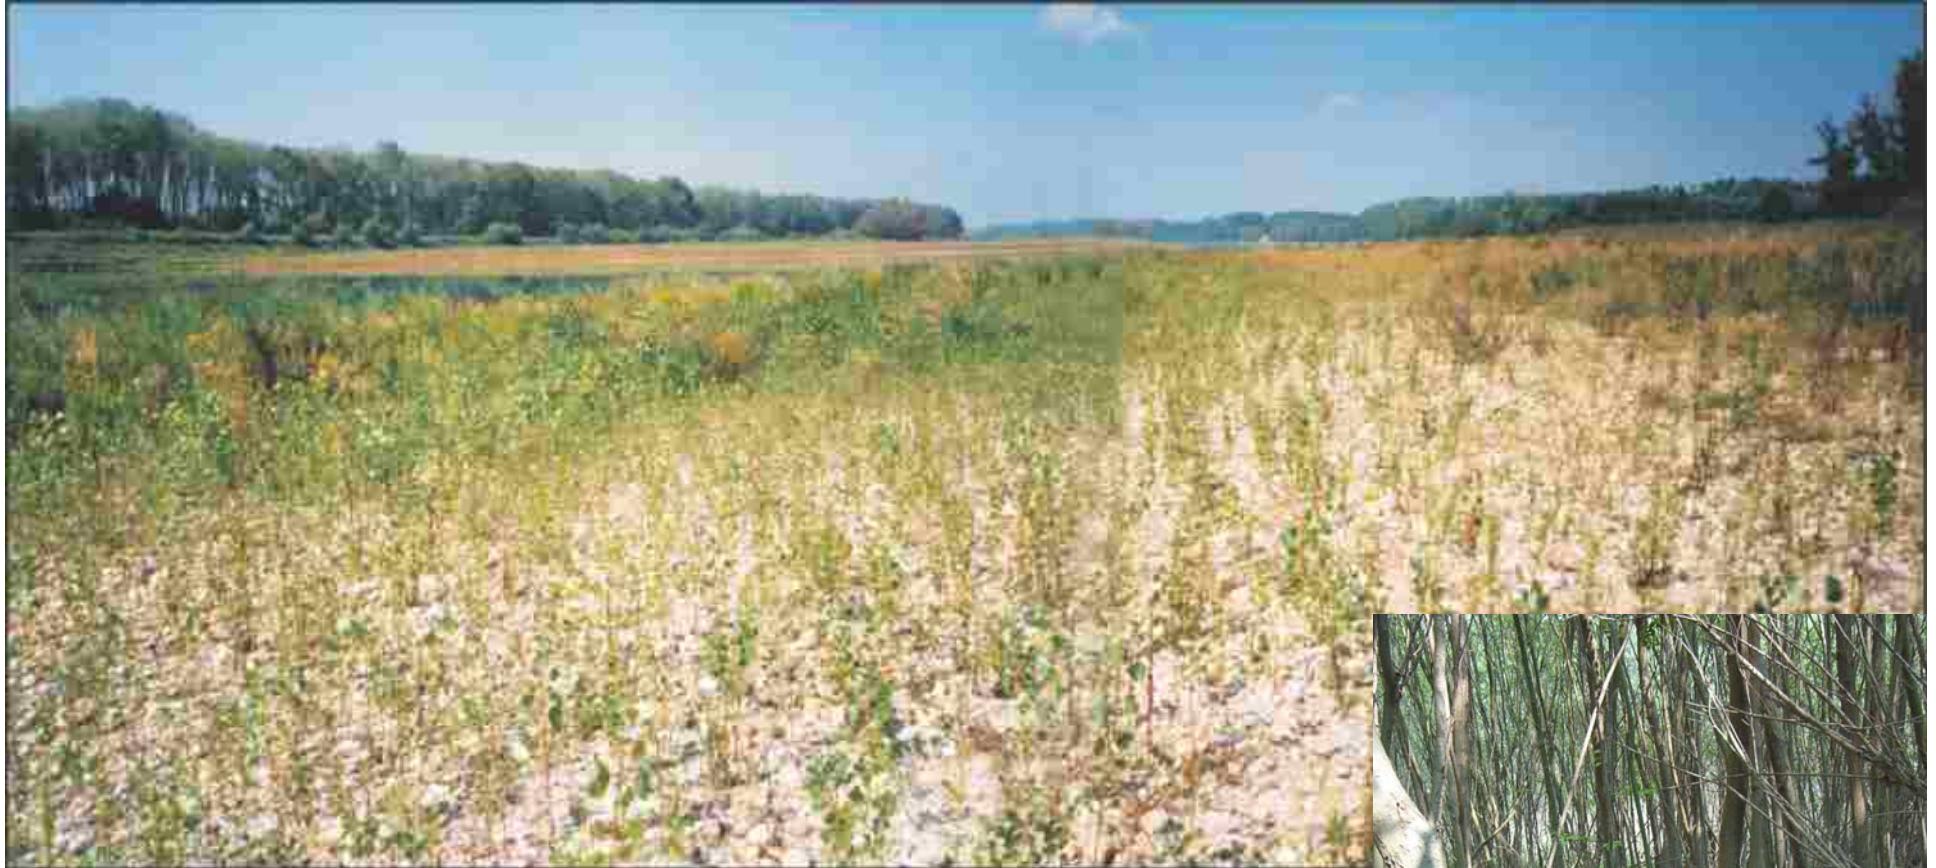
**Old Danube riverbed, initial tree regrowth
on the bare gravel bar, river kilometre 1833.
State: 7 September 1994.**

**The same place 10 years
after (April 2004)**

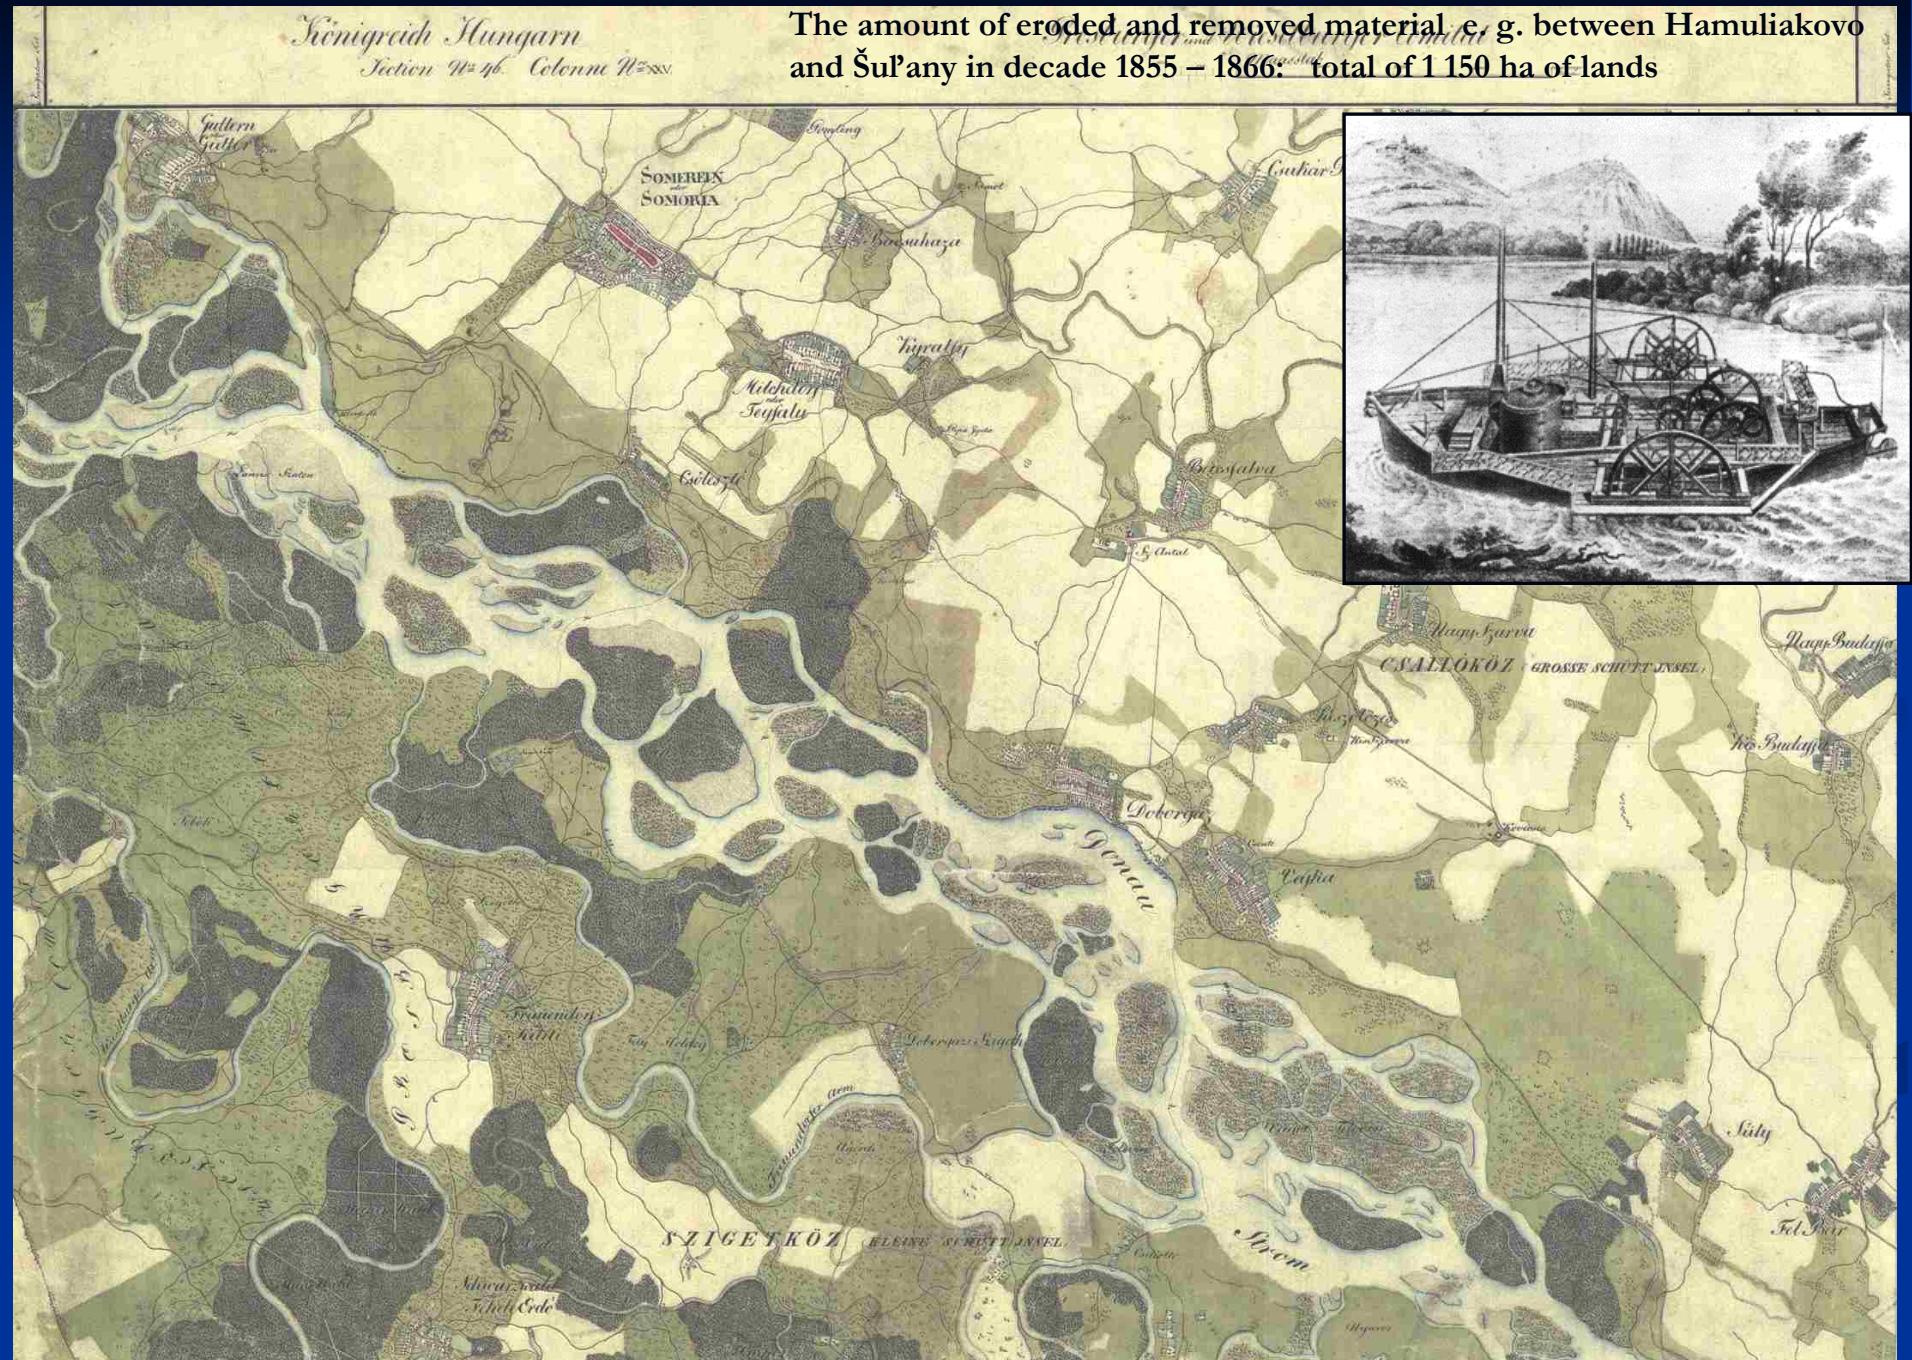
Danube mainchannel in 1840, on the sheet of the II. military mapping

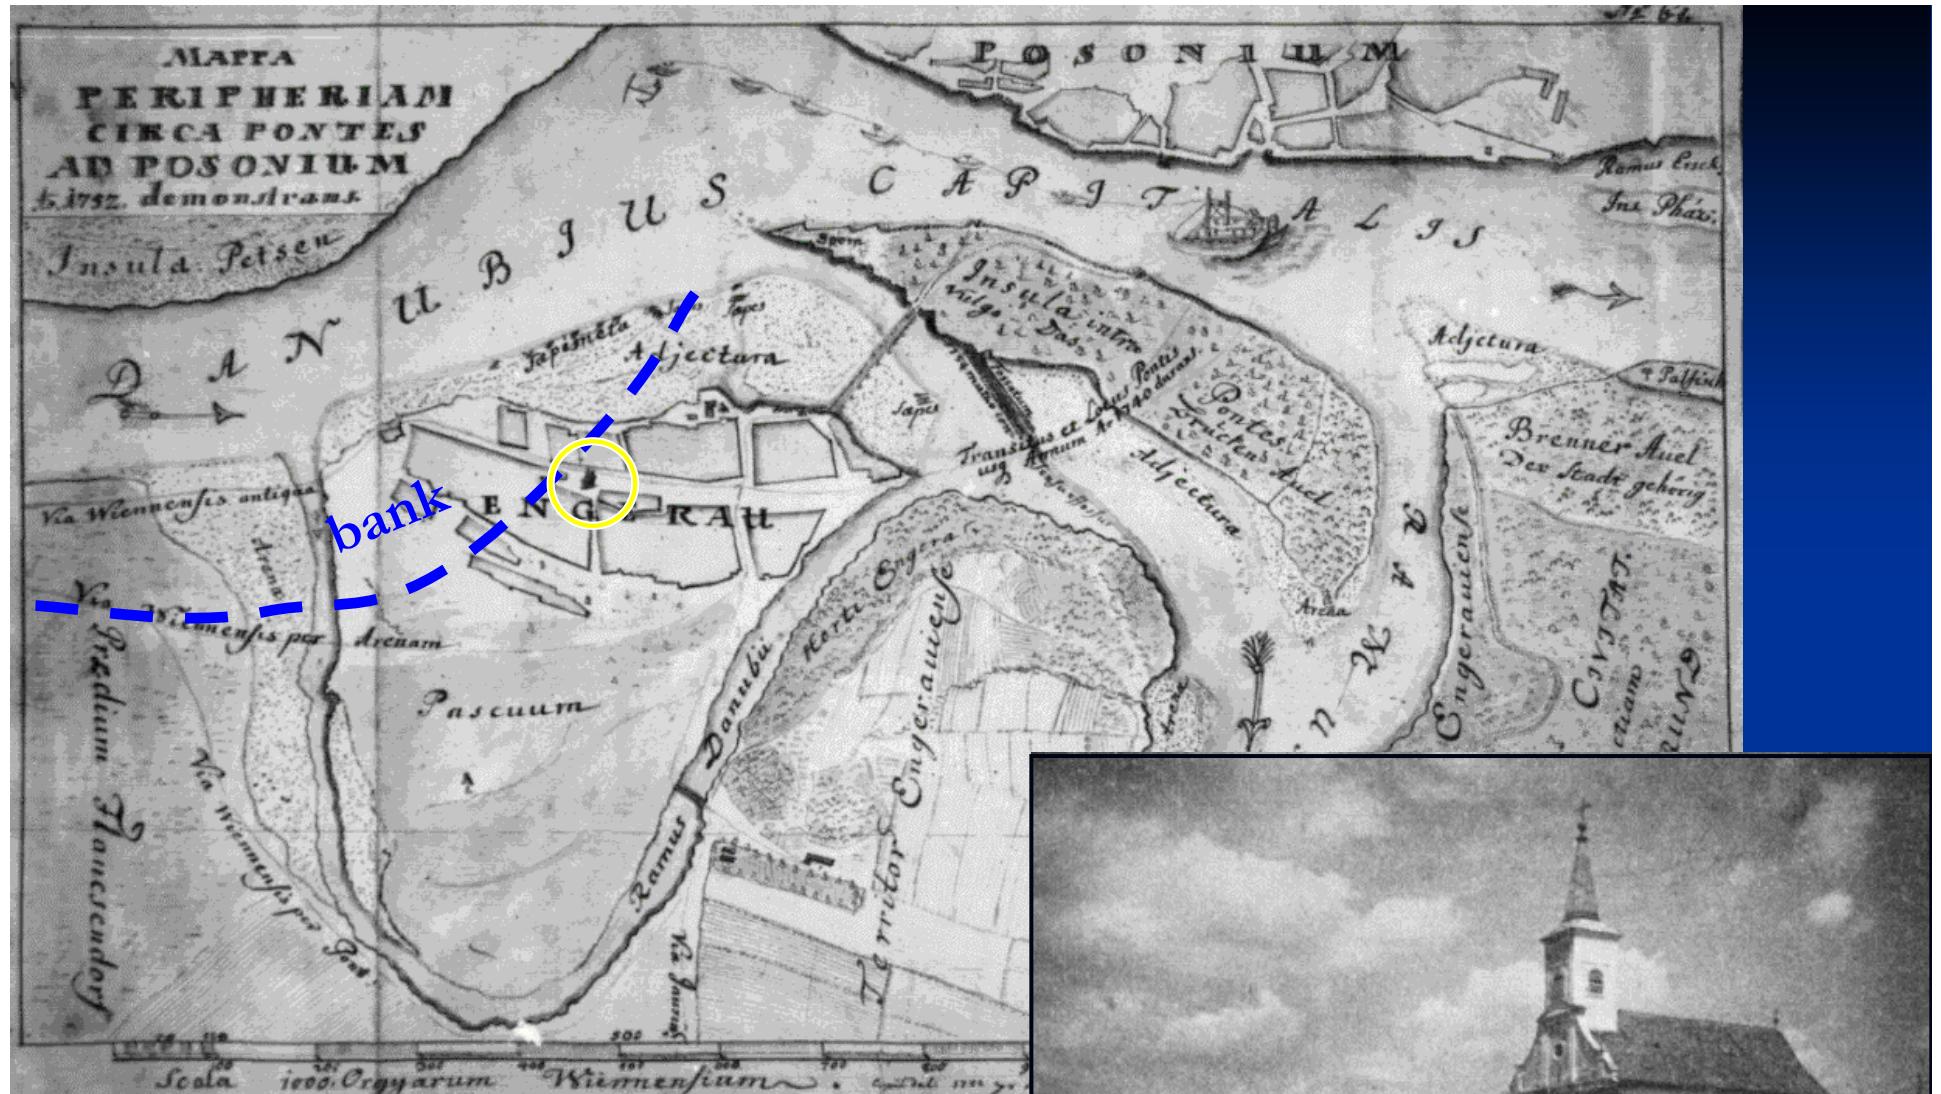
between 1753 – 1769:
 lateral shift of 150 – 200 m
 annual erosion of 11 – 17.5 m.yr⁻¹

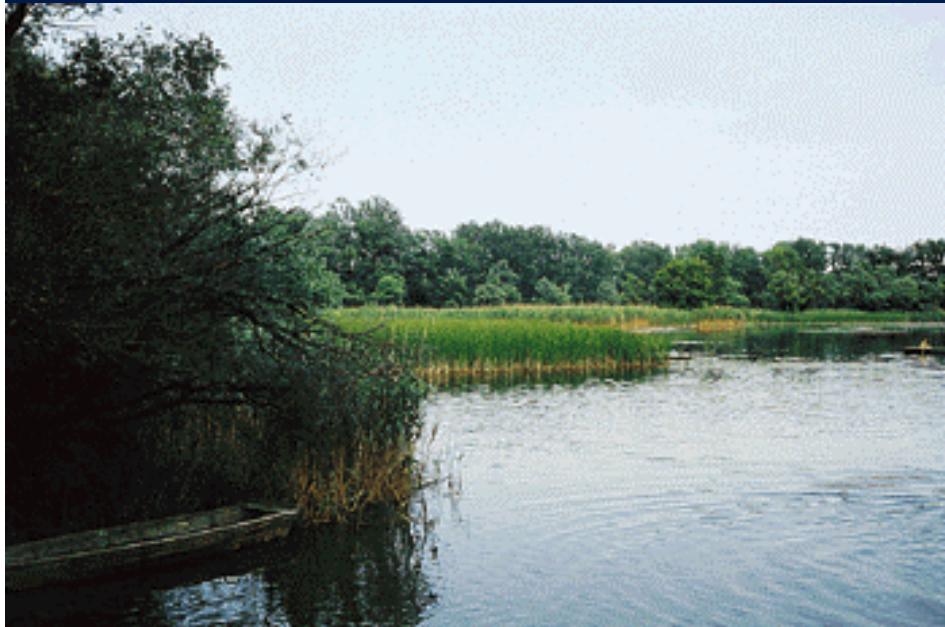
- 1796 – across the Bajcsi island, remnants:

Csápolnaki (Holt)Duna -
(at Nagybajcs)

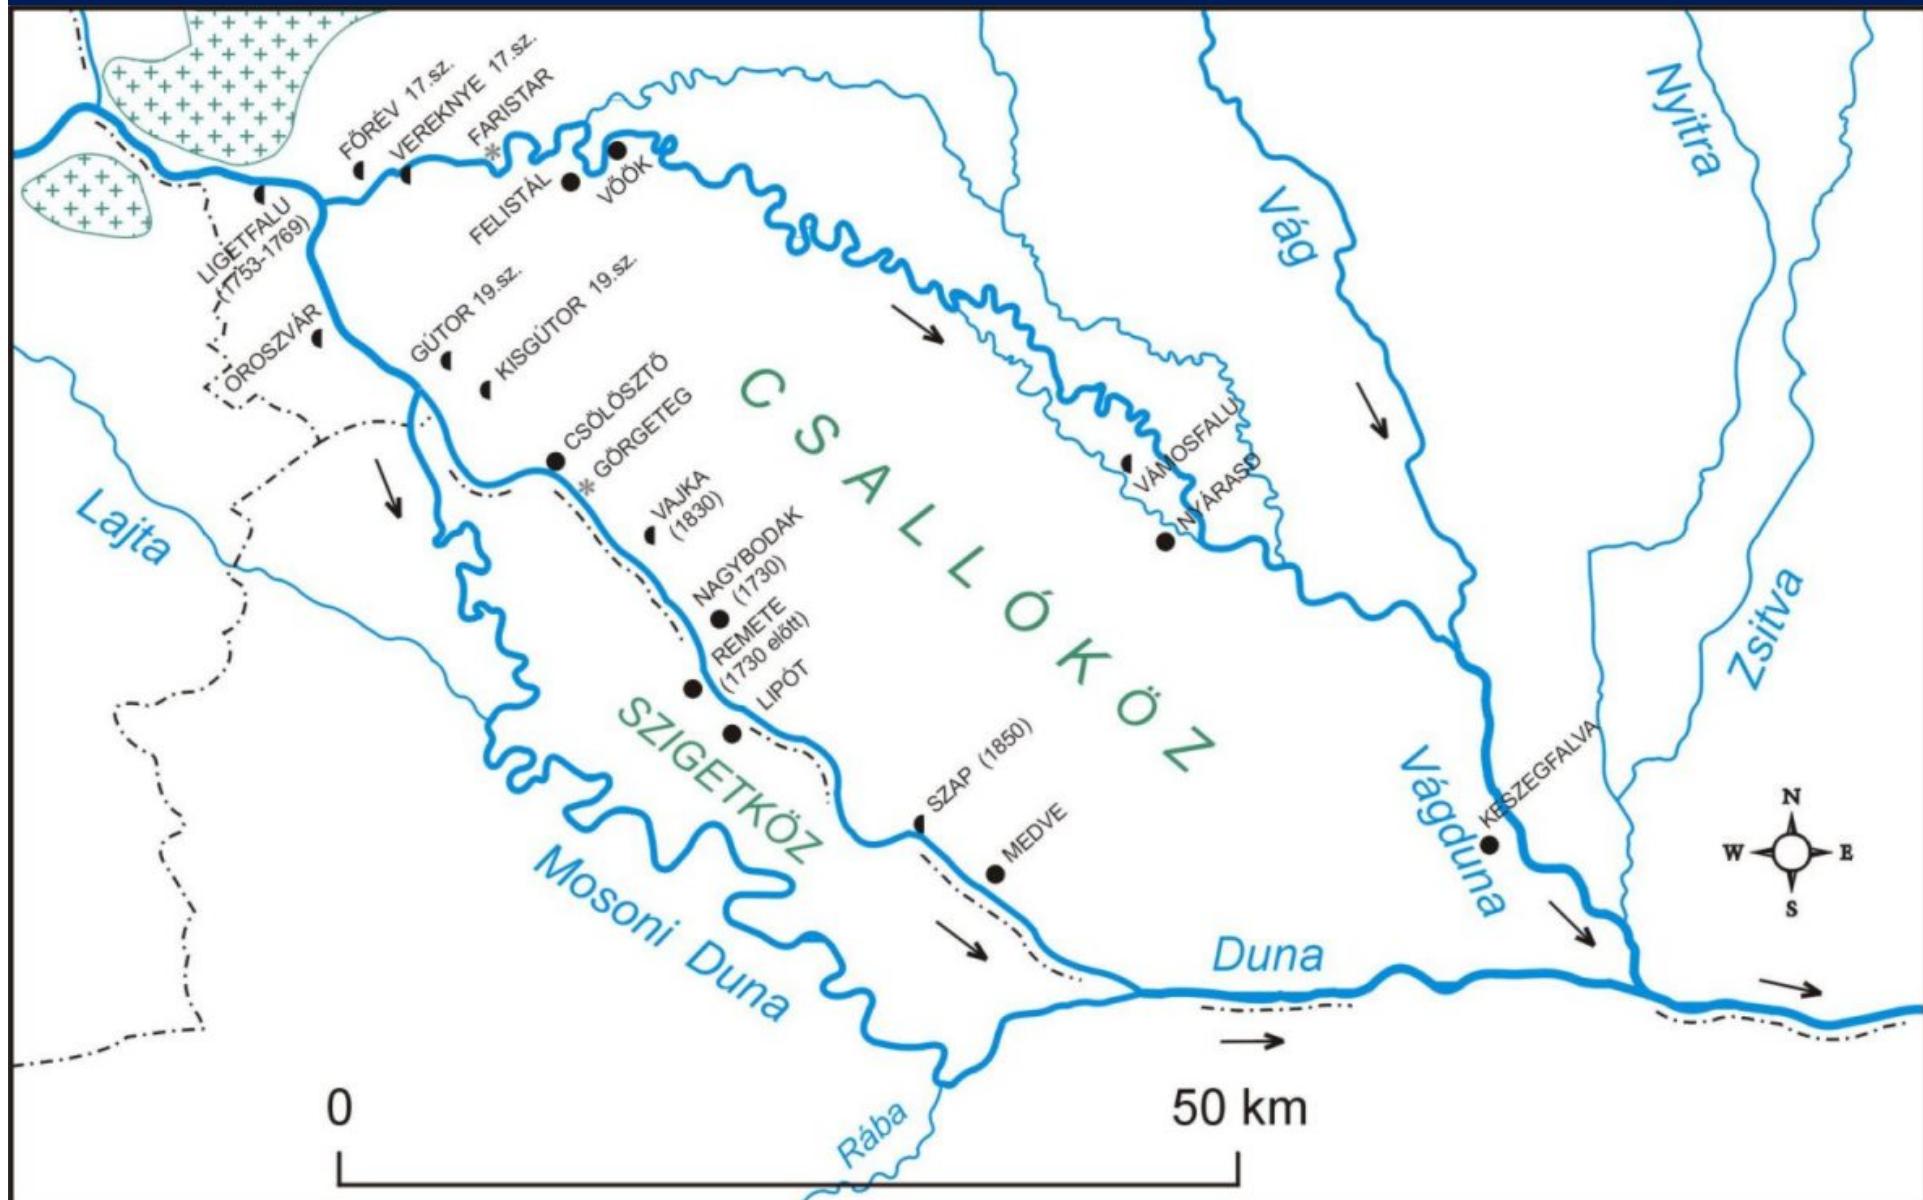
Villages destroyed and/or removed to new localities by the Danube erosion
